NASA CR-72996  
BAC Report No. 8489-945001

# FINAL REPORT

## ADVANCED THRUST CHAMBER DESIGNS

Contract NAS 3-7968

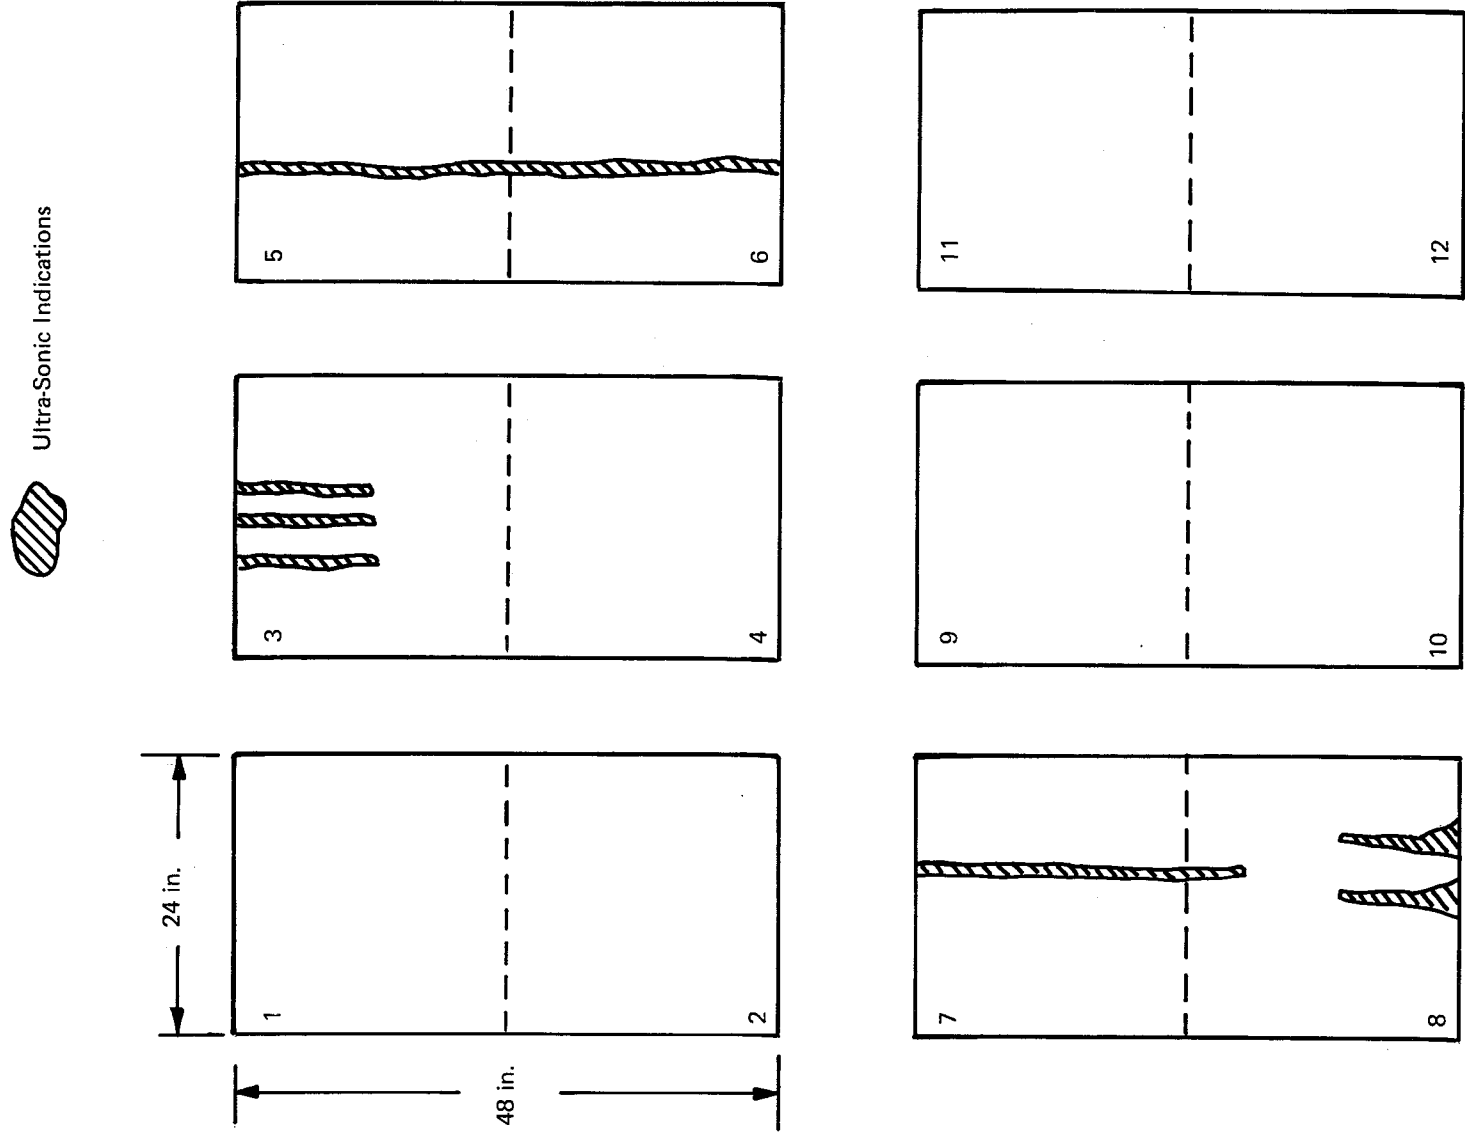
Figure 3. Locations of Discontinuities in TD Nickel Sheets

The three plates were cut into six plates 24 inches wide by 48 inches long. Discontinuities as determined by ultrasonic inspection were outlined on these plates. Figure 3 shows the location and extent of the discontinuities. Disks having a 24 inch diameter were cut from the TD Nickel plate. Each 24 inch x 48 inch plate yielded two disks.

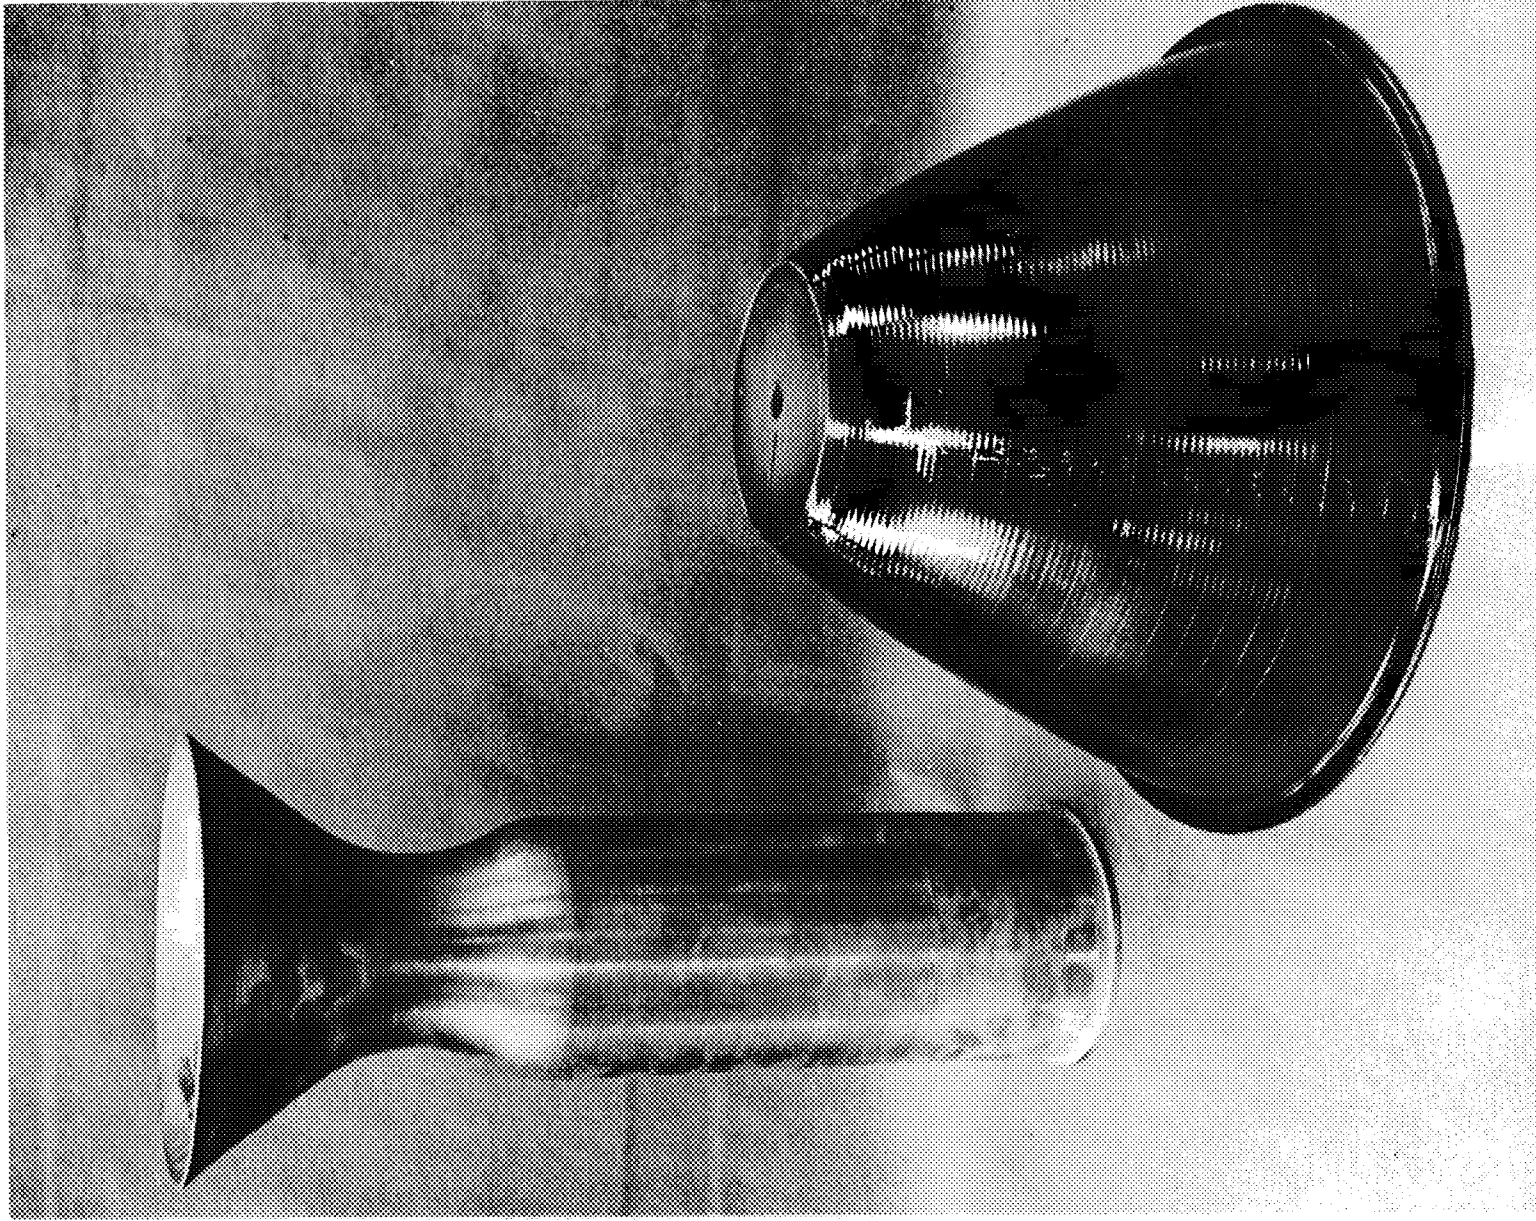
Figure 6. Defective Aft Liner Section

Figures 5, 6 and 7 illustrate successful and unsuccessful attempts at spin forming. Defects in the aft sections shown are the results of spin forming blanks with known areas of delamination. The fracture in the forward section shown in Figure 5 is the result of excessive reduction during a single spin forming stage.

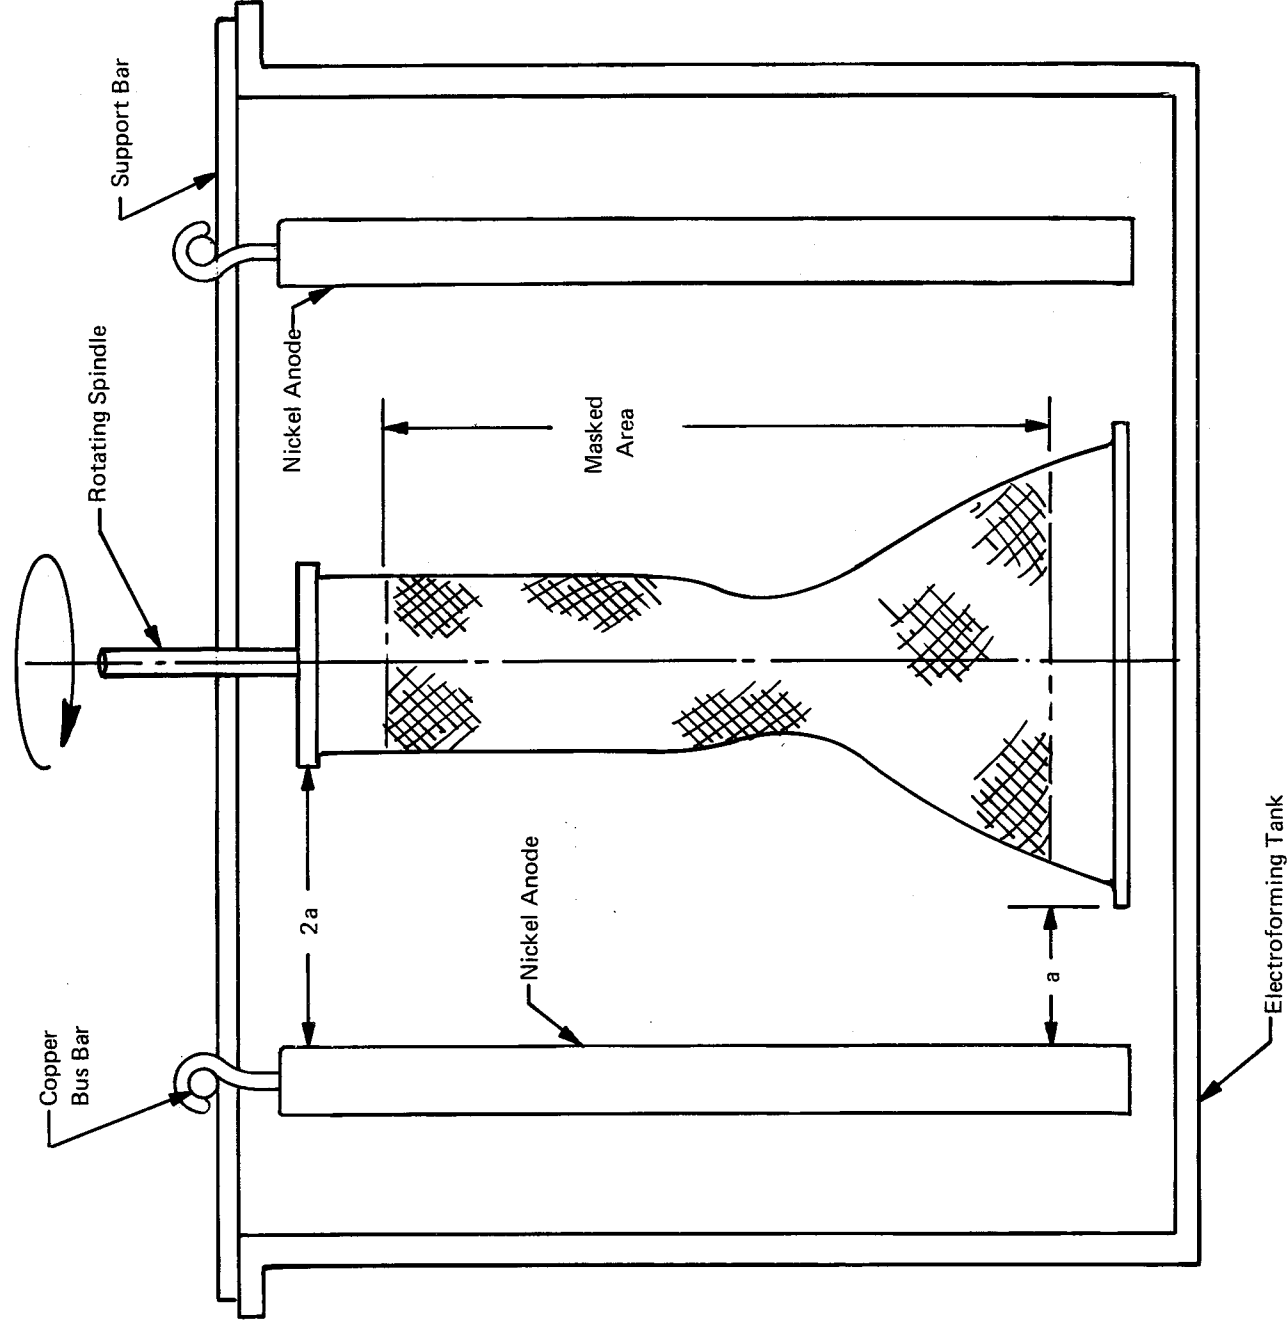
Figure 13. Electroforming of Liner Flanges

A procedure was needed for electroforming forward and aft inner liner flanges. This electroforming operation was completed before electric discharge machining of coolant channels and subsequent electroforming of the outer shell. The stainless steel slave liner was set up for electroforming as shown in Figure 13. The inner liner was mounted on a rotating spindle with both ends plugged and was immersed in the nickel sulfamate bath. A copper buss-bar supported the nickel anodes adjacent to the immersed liner. Another view of this setup with the liner withdrawn from the bath is shown in Figure 14. Figure 14 also shows the liner after a thin layer of nickel had been deposited at both the forward and aft flange areas.

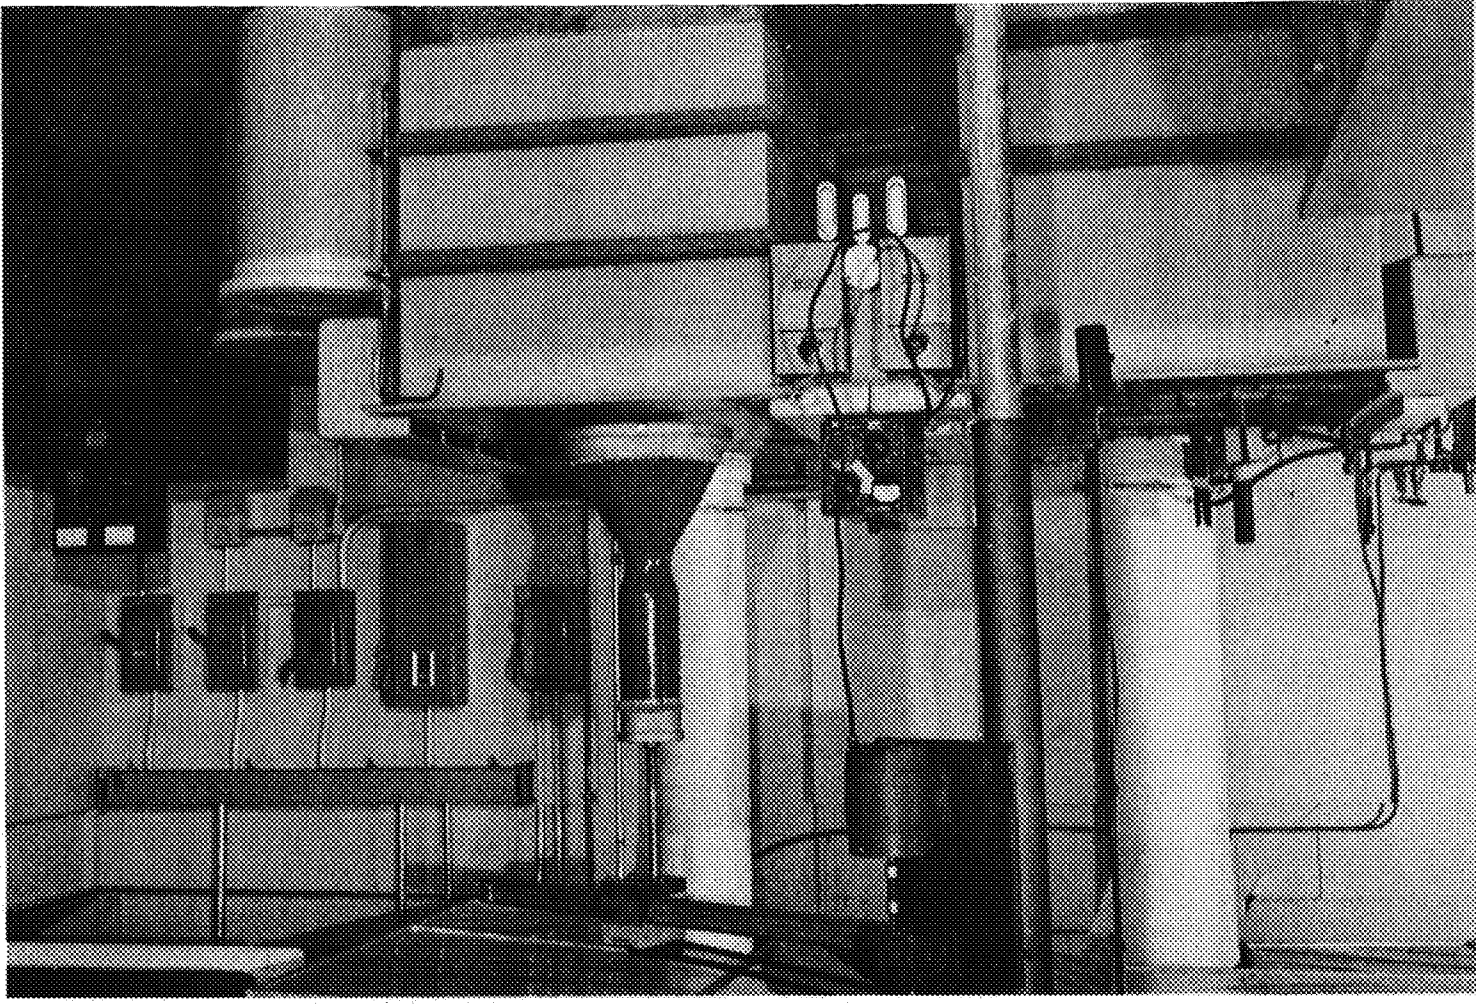
Figure 14. Partially Electroformed Flanges on Rocket Thrust Chamber

Nodular growth, caused by high current densities at the edges of the flanges, was not completely eliminated. The extent of nodular growth is illustrated in Figures 14 and 15. The rate of nodular growth was somewhat inhibited with procedures established for preferential deposition (use of plastic shields).

Preferential deposition of nickel was needed because of the insufficient rate of deposition in the flange radii, too-rapid deposition at the flange edges in the area of high current density, and because of the nodule buildup. Preferential deposition was accomplished with the use of auxiliary anodes, shields, the addition of masking in flange areas to preclude buildup, and the addition of thief rings and bi-polar anodes. Arrangements employed for preferential deposition are illustrated in Figures 16, 17, and 18. Use of non-metallic shields and masking reduced or eliminated plating current in specific areas where retardation of plating was desired. Auxiliary anodes increased the plating rate where desired.

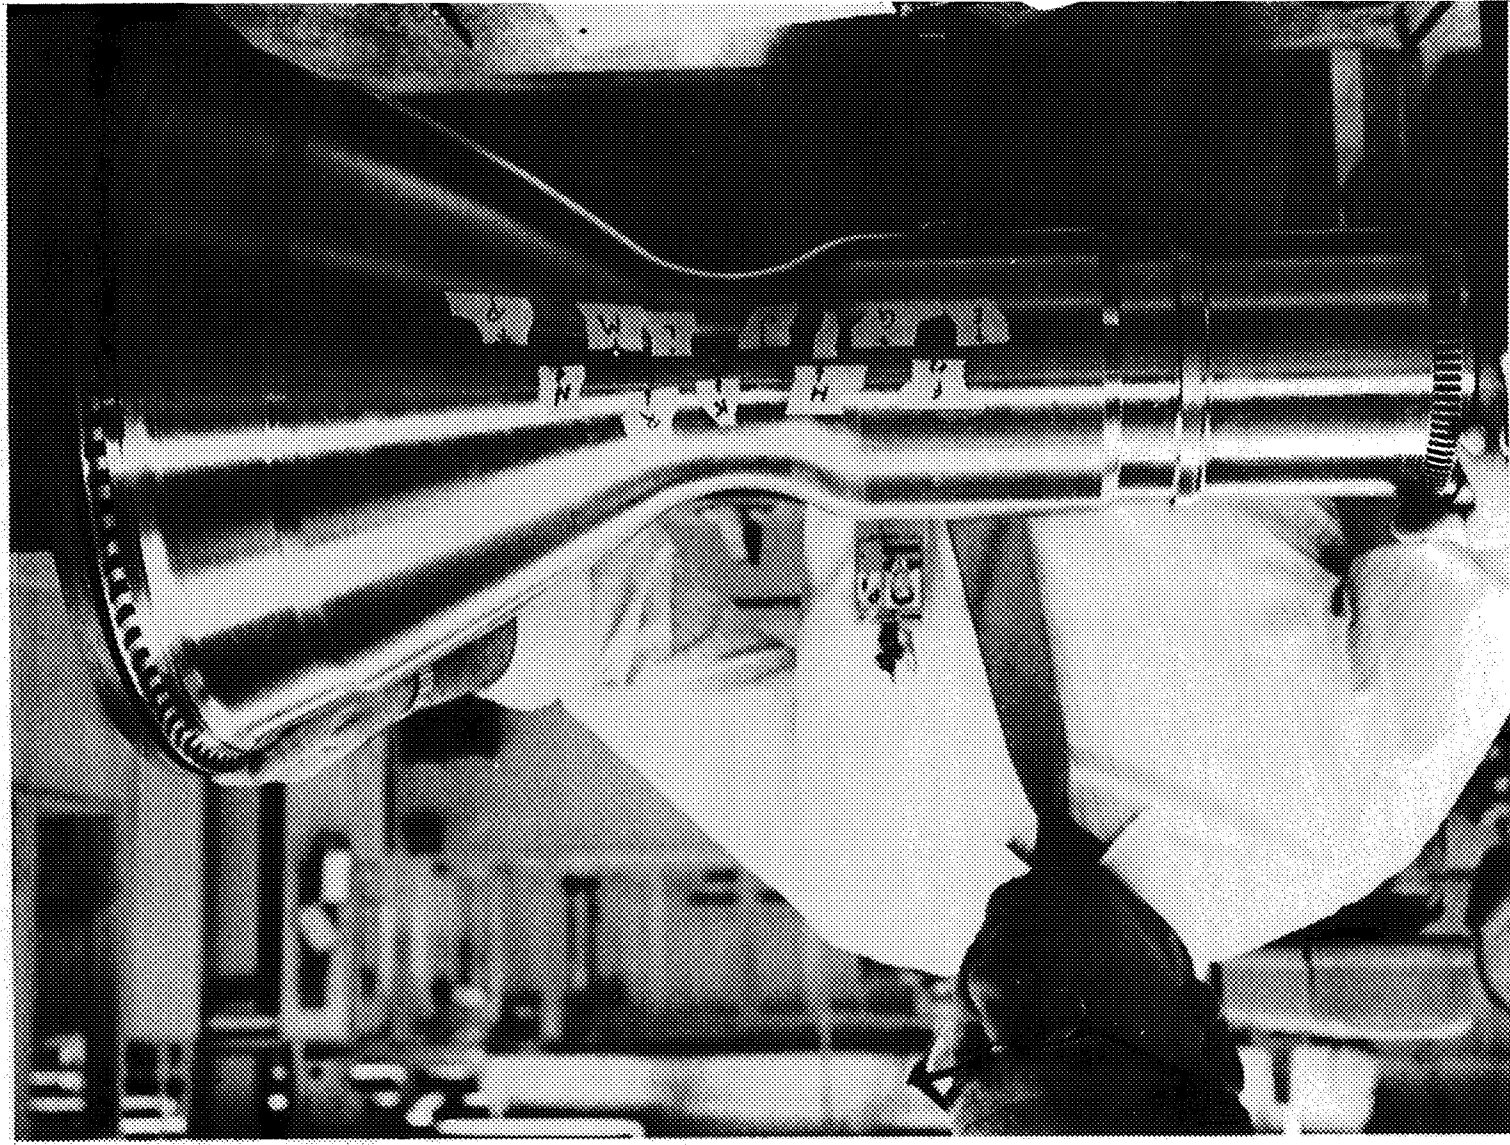
Figure 41. Instrumentation Hole Layout

The chamber was again set up on centers as shown in Figure 41. To simplify instrumentation hole location, and to correct for any misalignment of hole entry point due to glass rod tipping during the outer shell electroforming operation, the instrumentation hole pattern was laid out on the outside surface of the chamber as is evident in Figure 41. The glass rods were removed from the outer shell using mechanical and chemical means. Mechanical means involved chipping and removing glass particles from the holes with use of an undersize drill and reamer. To insure complete glass removal, a 12% solution of hydrofluoric acid was used to dissolve the remaining glass in the holes. The acid was known to not attack nickel electrodeposits.

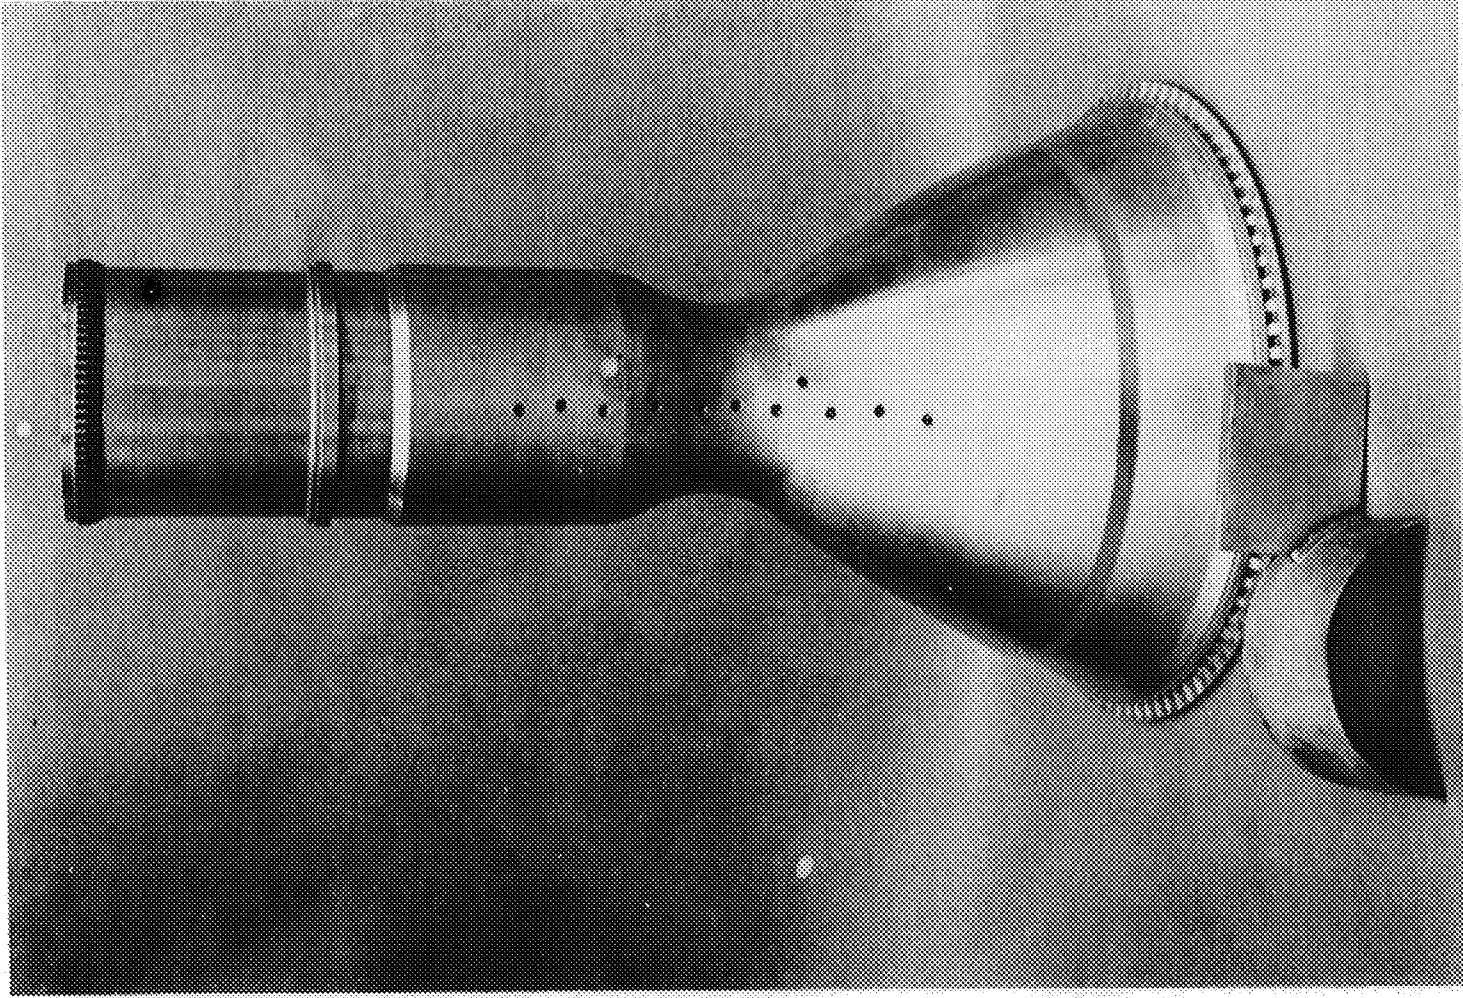
Figure 42. Chamber Drilled and Tapped for Instrumentation

Alignment of the holes and depth control for drilling, counterboring and tapping was assisted with optical equipment, and micrometer and dial indicator attachments on the milling machine. Figure 42 shows the TD Nickel chamber upon completion of the instrumentation hole drilling and tapping operation. The weld sample in the figure was made to establish the manifold to shell weld procedure. It was later metallographically evaluated and confirmed a structurally sound weld without degradation of the inner shell to electroformed shell interface.

Finished channel instrumentation holes, for thermocouples measuring coolant temperature during hot firing tests, were plugged with 1/8-inch stainless steel pipe plugs in preparation for subsequent chamber hydraulic pressure test. These are evident in Figures 2 and 43. It was not necessary to plug the blind land instrumentation holes for those thermocouples measuring chamber inner wall temperatures.

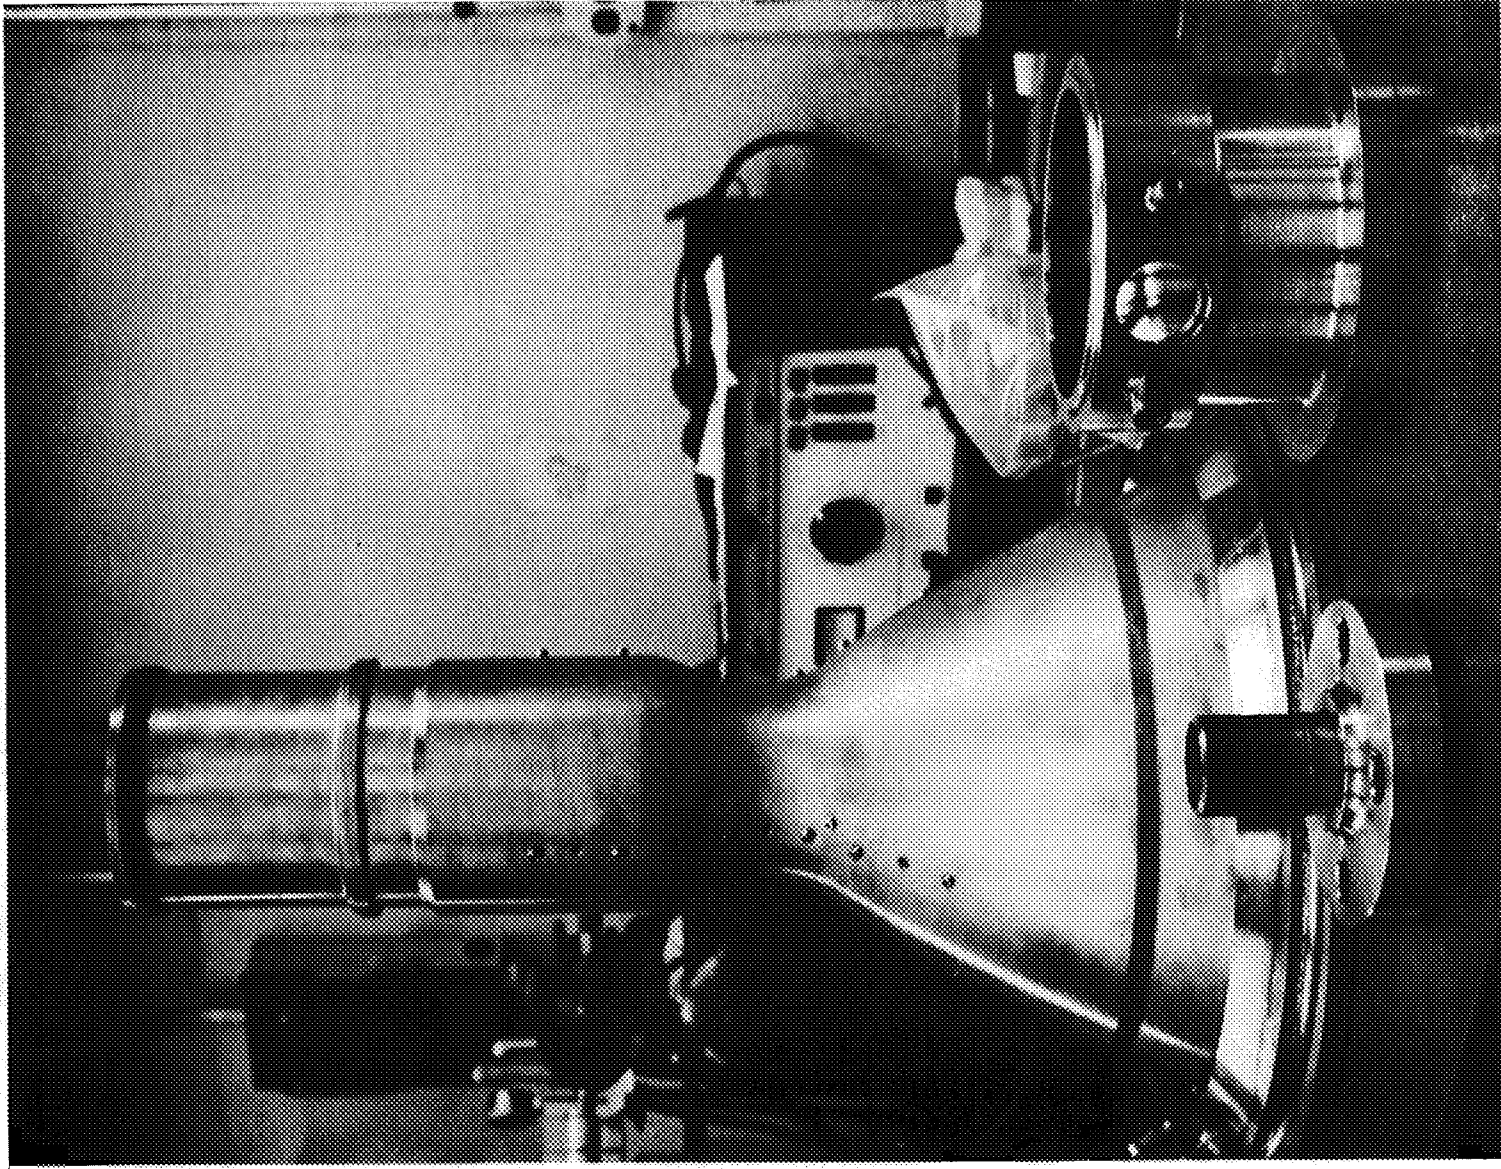
Figure 43. Final Weld Buildup of Chamber

The first step in weld build-up to final configuration consisted of welding the threaded bosses to the forward and aft manifold members. The coolant inlet and outlet members then were welded into subassemblies. After completion of these subassembly operations, the aft manifold ring was welded to the aft liner flange and to the chamber outer shell. The manifold to shell weld was made first in order to take advantage of the minimal restraint exerted by the tacked assembly. The flange to liner weld was made next. In both cases, two passes were required and a skip sequence was used with welds being four inches to five inches long, approximately 180 degrees apart, and the sequence continued until the circumference was completely welded. At this point a dye penetrant and helium sniffer detector test was made to verify no-leak welds. The coolant inlet assembly was then welded to the aft ring manifold. Figure 43 shows the weld build up of the final chamber assembly at this point.

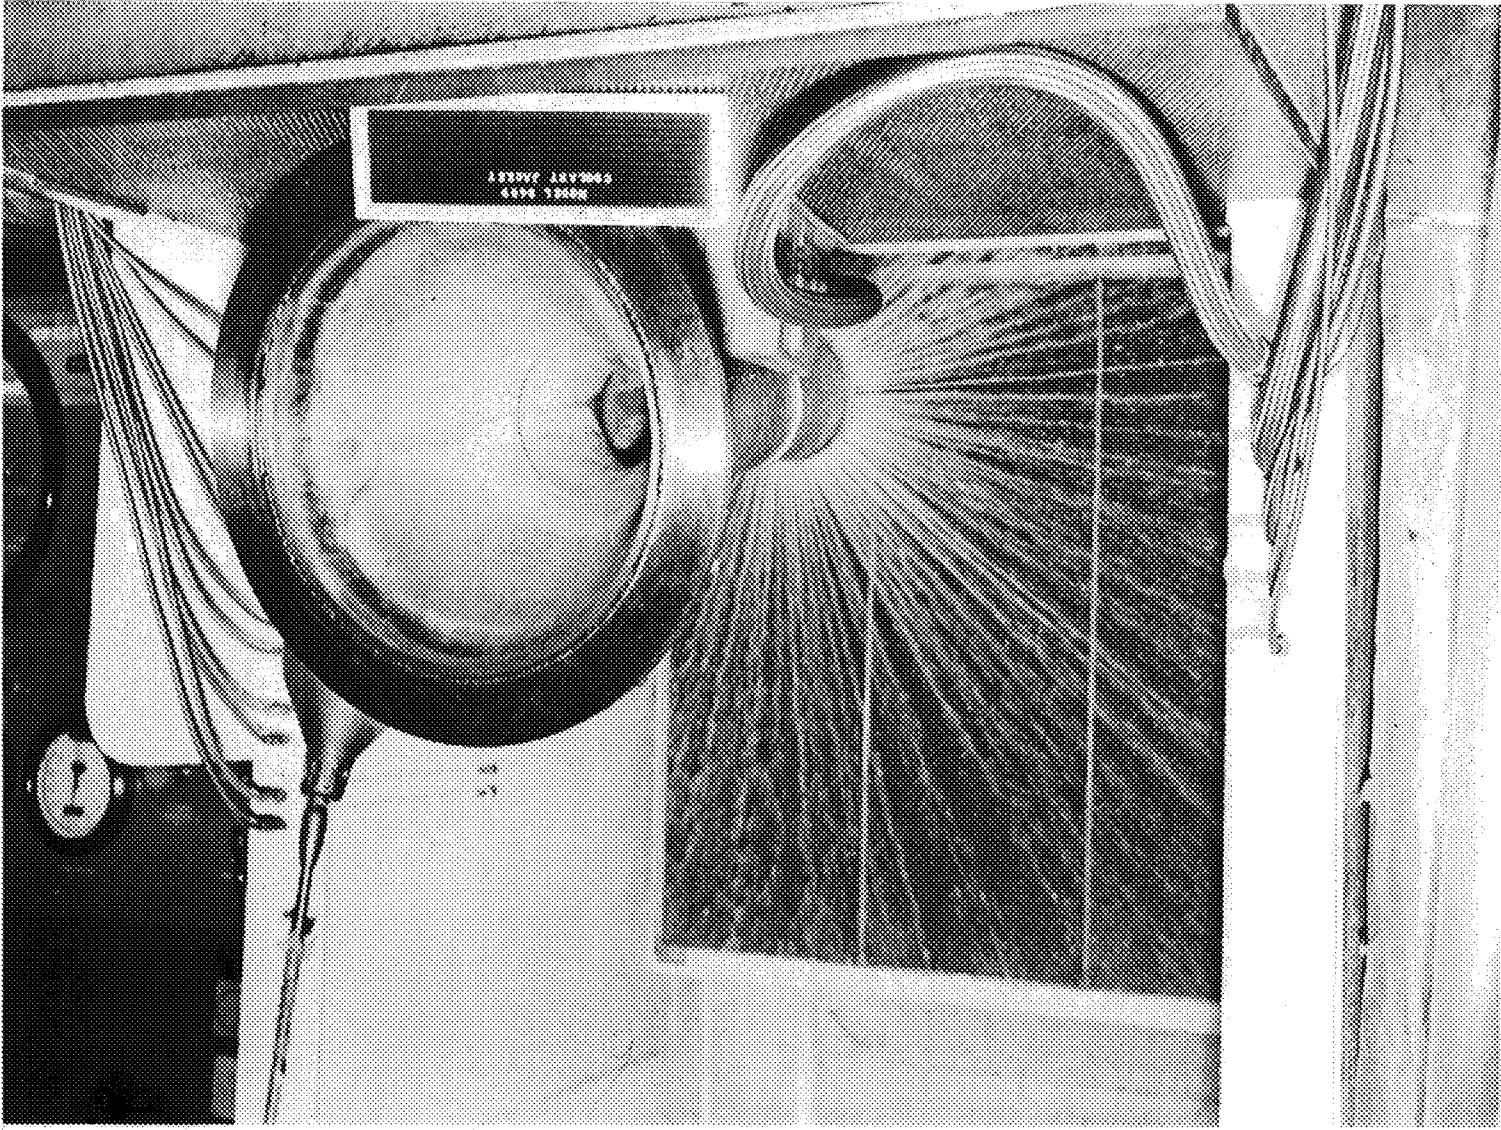
Figure 44. Water Flow Check

To insure that all passages were open, a water flow check was made after the aft manifold was welded and before the front manifold was assembled. A water line was attached to the aft inlet and low pressure water flow was started so that a visual inspection could be made of the flow through each channel. The pressure was increased to a manifold pressure of approximately 200 psi. There were no differences in the flow characteristics of channels, showing that all channels were open. The water flow check is shown in Figures 44 and 45.

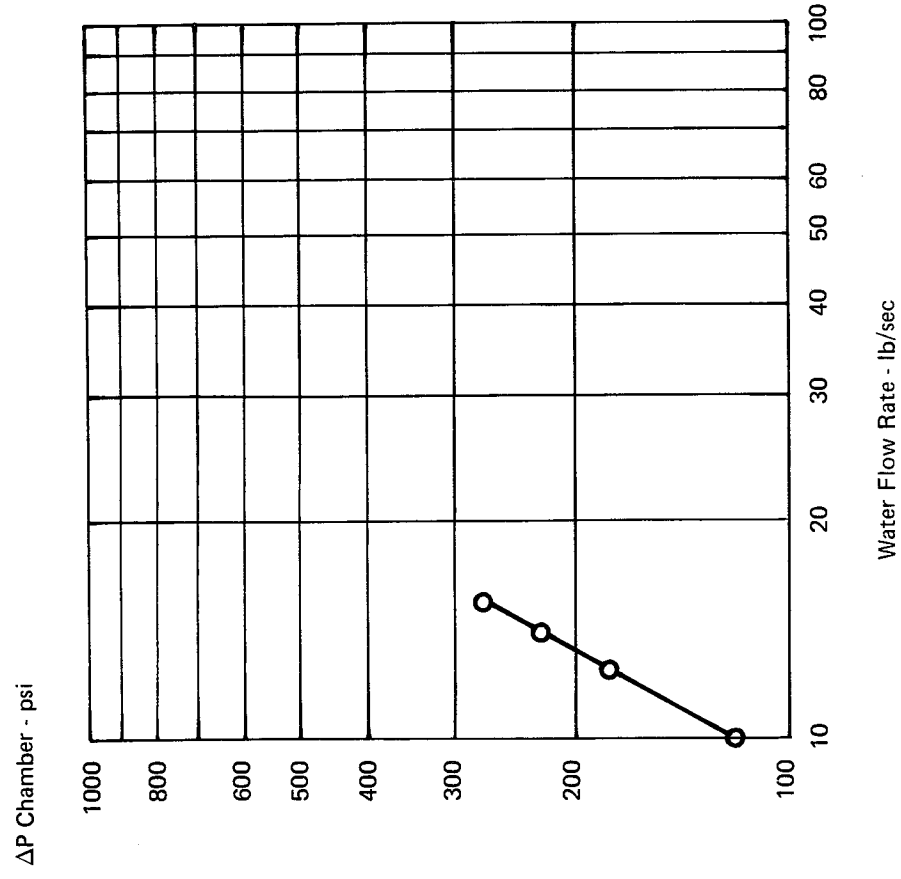
Figure 46. Thrust Chamber Flow Calibration

The chamber was next calibrated for flow test pressure drop. Water was used as the flow medium and inlet pressures were recorded for 10, 12.5, 14, and 15.5 lb/sec flow rates. Results are shown in Figure 46.
